Small Wind Turbine Testing Results from the National Renewable Energy Lab

Amy Bowen, Arlinda Huskey, Hal Link, Karin Sinclair, Trudy Forsyth, David Jager
National Renewable Energy Laboratory

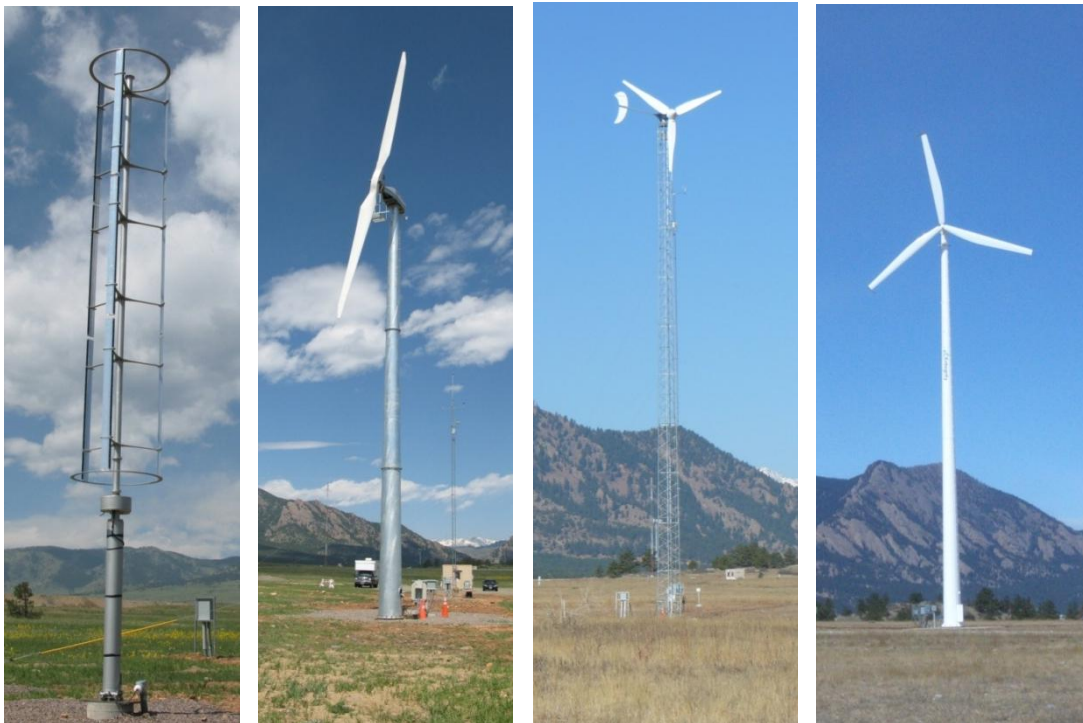
Figure 1. From left to right: the Windspire, the Gaia-Wind 11 kW, the ARE 442, the EW50

The turbines selected in the first round of the independent testing project were the Mariah Power Windspire, the Gaia-Wind 11 kW, the Abundant Renewable Energy ARE 442, and the Entegrity EW50. Figure 1 shows the selected turbines installed at the NWTC. Power performance, duration, noise, and safety and function tests are performed on all turbines. Power quality testing is performed only on three-phase turbines, as the IEC Standard 61400-21 only applies to turbines with a three-phase grid connection. The available preliminary results of those tests to date are presented below and are subject to change.

The Mariah Power Windspire was installed on May 5, 2008. It is a 120 VAC, single-phase, grid-connected, permanent-magnet generator wind turbine rated at 1 kW. The Windspire is a vertical-axis Giromill turbine mounted on a monopole tower, and has a rotor height of 6.1 m and a rotor area of 1.2 m by 6.1 m. Testing on the Windspire was terminated on January 14, 2009 after repeated turbine problems. Partial power performance and safety and function test data was collected on the Windspire.

The Gaia-Wind 11 kW turbine was installed on May 13, 2008. It is a downwind, two-bladed, horizontal-axis turbine. Its three-phase 11-kW induction generator delivers 480 VAC to the grid. The Gaia-Wind 11 kW has a 133 m² swept area and is mounted on an 18.2-m monopole tower. At the time of this writing, data collection for duration, safety and function, and power performance testing was complete and power quality and acoustic noise testing were in progress.

The Abundant Renewable Energy ARE 442 was installed on June 11, 2008. It is a horizontal-axis, three-bladed turbine with a swept area of 41 m². It operates upwind from the prevailing wind direction and uses a furling mechanism for power control. The ARE 442 is mounted on a 30.5-m lattice tower. The turbine is a single-phase, grid-connected, permanent-magnet machine that is rated at 10 kW at 240 VAC. At the time of this writing, data collection for power performance testing was complete and duration, safety and function, and acoustic noise testing were in progress.

The Entegriety EW50 was installed on March 3, 2009. The Entegriety's three-phase induction generator produces 50 kW at 480 VAC. Its rotor-swept area is 176.7 m² and it operates downwind. It is a horizontal-axis machine mounted on a 30.5-m monopole tower. At the time of this writing, data collection had begun for power performance, acoustic noise, safety and function, and duration testing of the Entegriety.

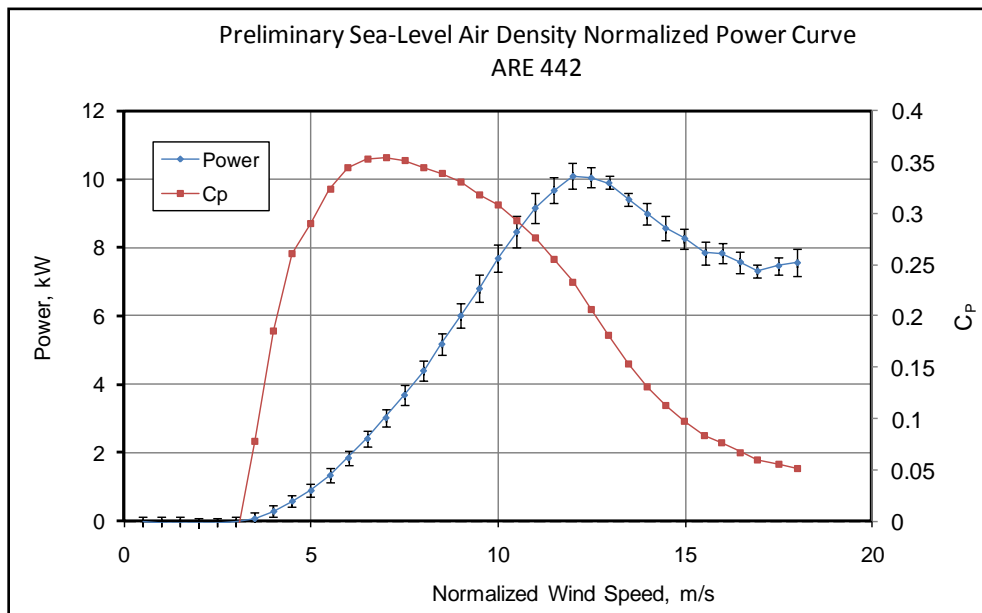
Figure 3. Preliminary power and C_p curves for the ARE 442

Preliminary power and C_p curves for the Gaia-Wind 11 kW are displayed in Figure 2. The power curve for the Gaia-Wind 11 kW shows power measurements that are greater than rated power. Preliminary power and C_p curves for the ARE 442 are displayed in Figure 3; this turbine performed as expected.

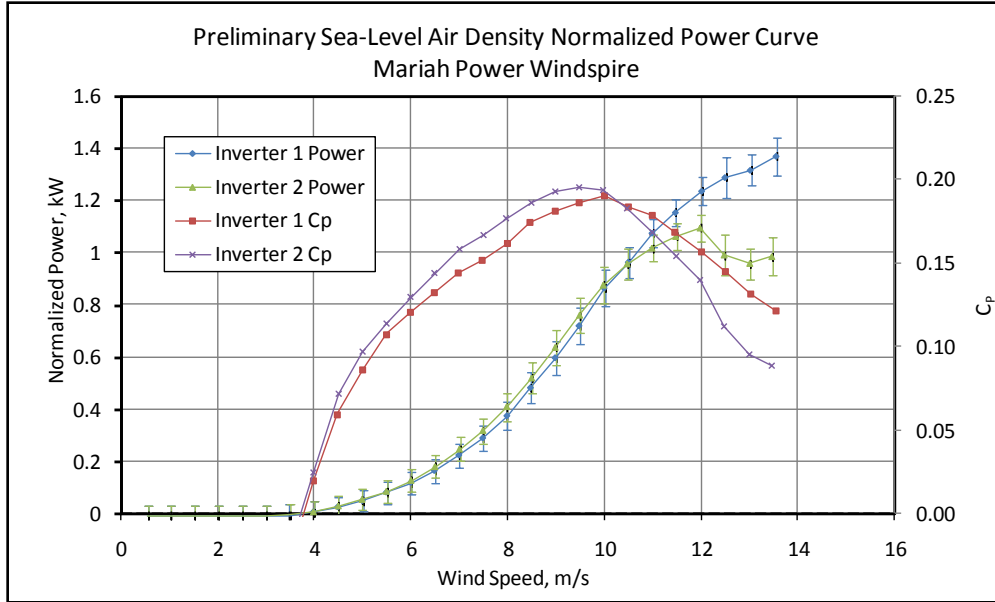
Figure 4. Mariah Power Windspire preliminary power and Cp curves for the power optimized inverter (Inverter 1) and the production inverter (Inverter 2)

The original inverter on the Windspire was optimized for power performance and failed after several months of operation. After the failure, a production model inverter was installed and operated until testing on the Windspire was suspended. The required amount of data was not collected on either inverter due to failures, however the incomplete preliminary power and C_p curves for both configurations are shown in Figure 4.

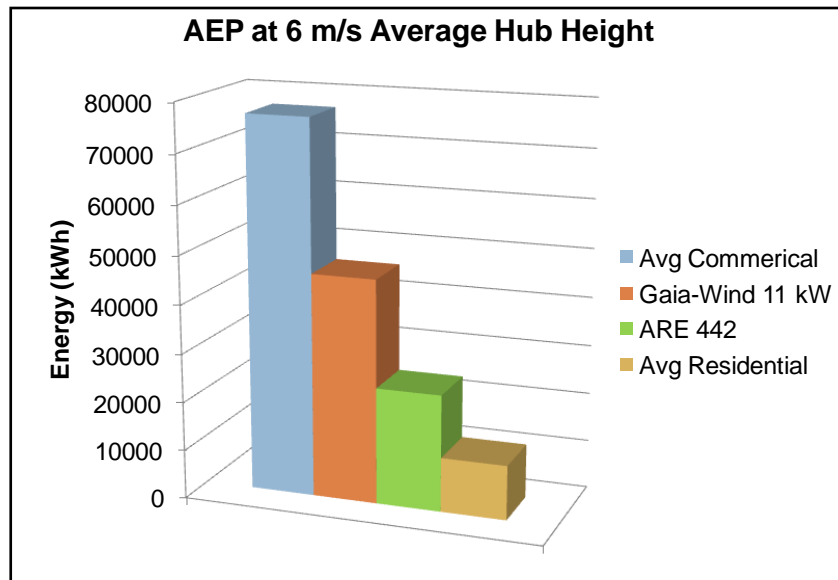
Figure 5. Average annual energy used by consumers compared with annual energy production at a hub-height wind speed of 6 m/s

The average annual energy usage per household is approximately 11,000 kWh and the average energy usage per commercial establishment is approximately 77,000 kWh (Energy Information Administration 2009). Figure 5 shows the average annual energy used by consumers compared with the AEP estimated at an average hub-height wind speed of 6 m/s for the ARE 442 and Gaia-Wind 11 kW.
